**FINAL SITE REPORT
ADDENDUM NUMBER 1**

**VASQUEZ BOULEVARD/INTERSTATE 70
DENVER, COLORADO**

ADDENDUM TO THE FINAL SITE REPORT VASQUEZ BOULEVARD/INTERSTATE 70

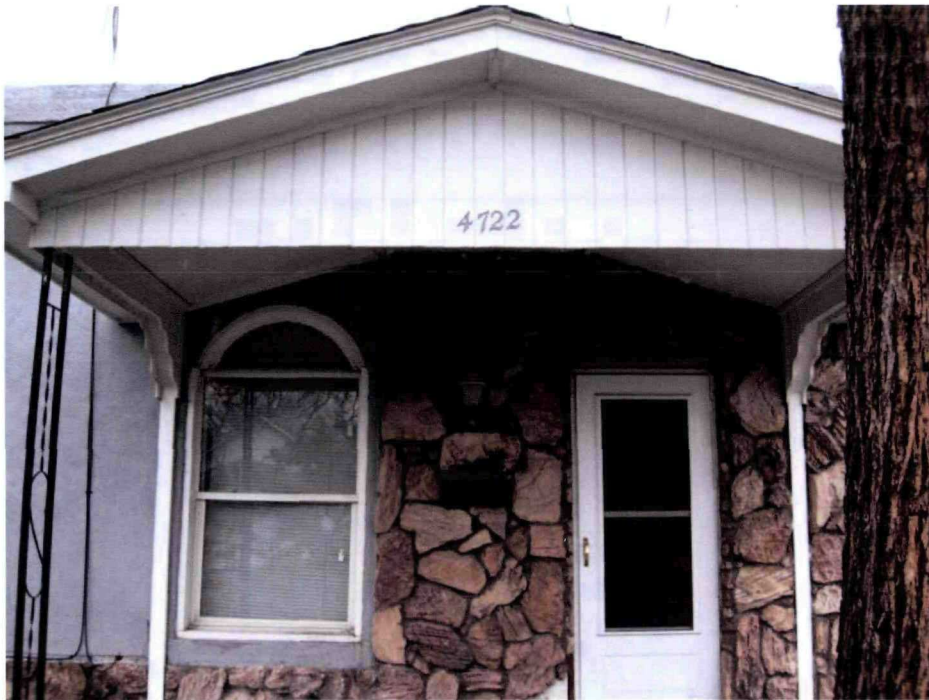
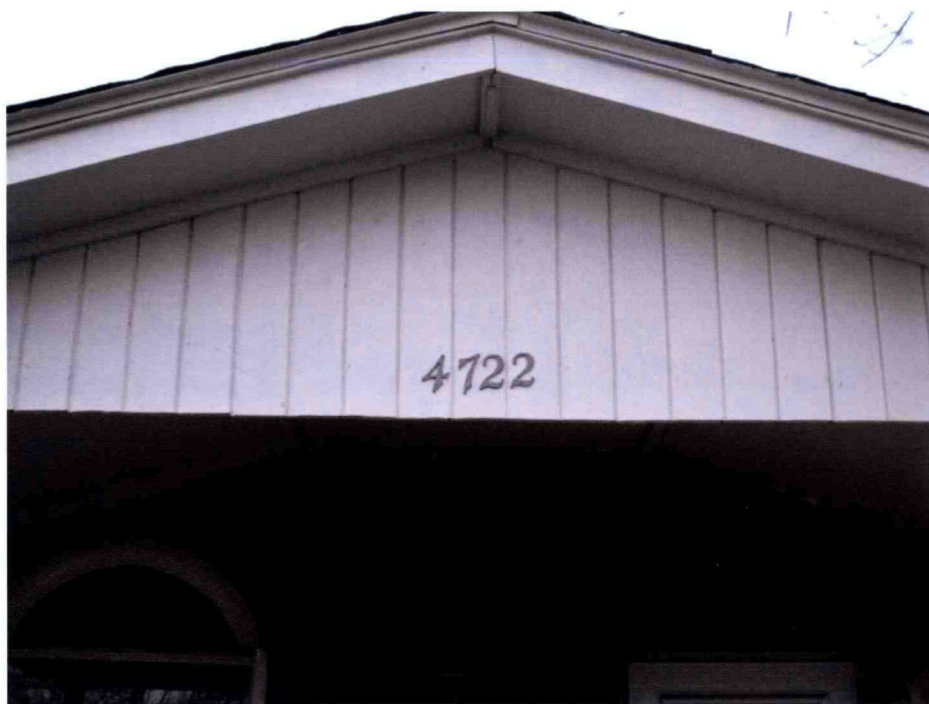
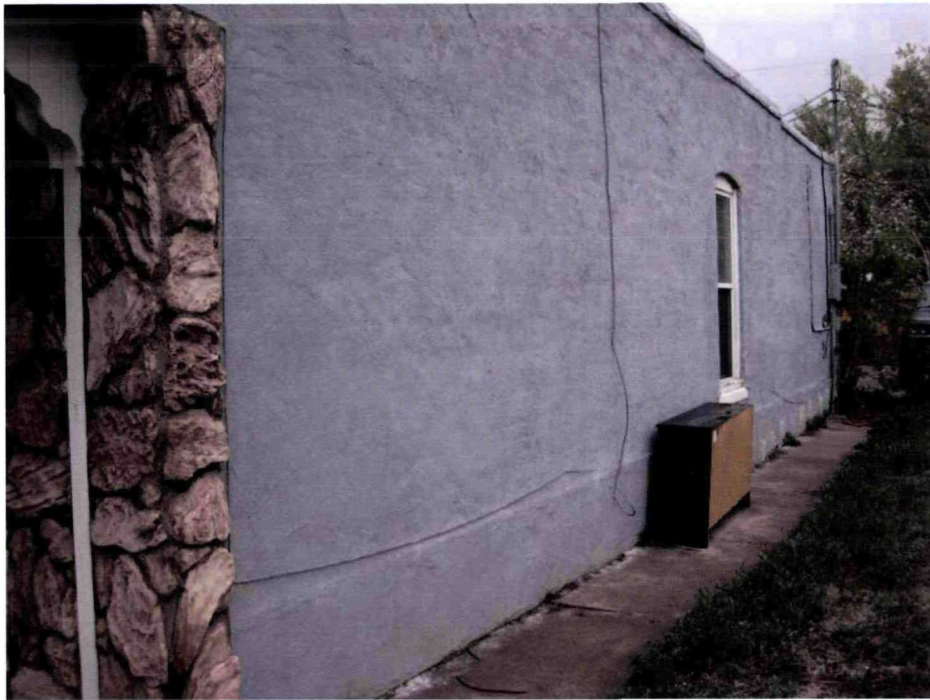
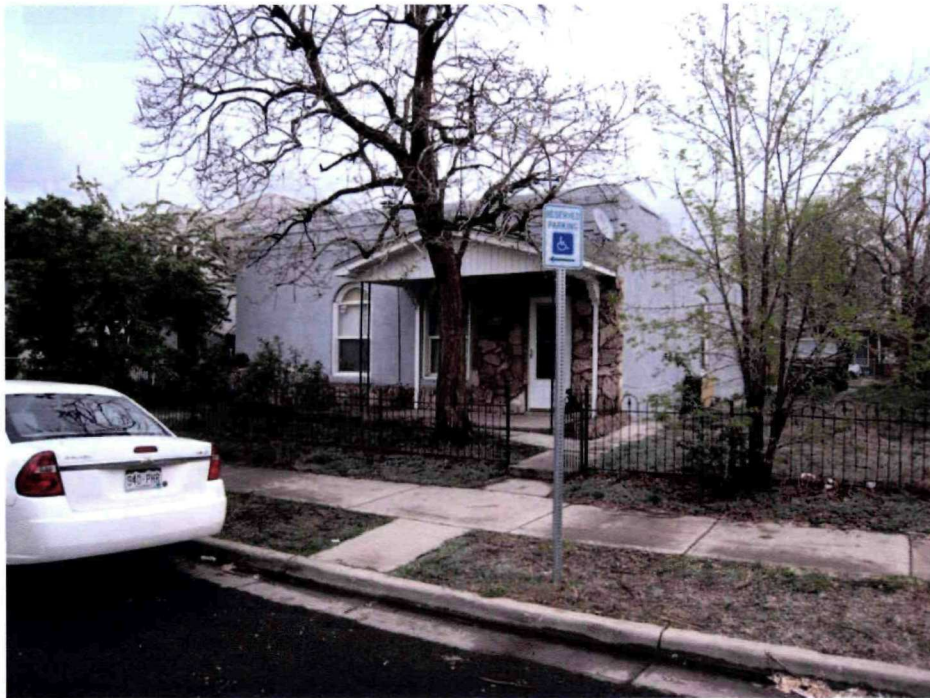
Photographs of Paint Condition at 4722 Race Street

For this project, lead-based paint assessments are conducted in order to “protect the remedy” at properties where soils are remediated due to lead concentrations above the action level. During this phase of the project, the only property that met this criterion was located at 4722 Race Street. Following a visual observation of all structures located on the property, it was determined that there was no peeling, chipping, or degraded paint that would potentially pose a threat of recontamination (Attachment D). Therefore, a lead-based paint assessment and/or abatement were not required at this property.
